CNG and Hydrogen Vehicle Fuel Tank Failure Incidents, Testing, and Preventive Measures

Robert Zalosh

Firexplo
Wellesley, MA
bzalosh@firexplo.com

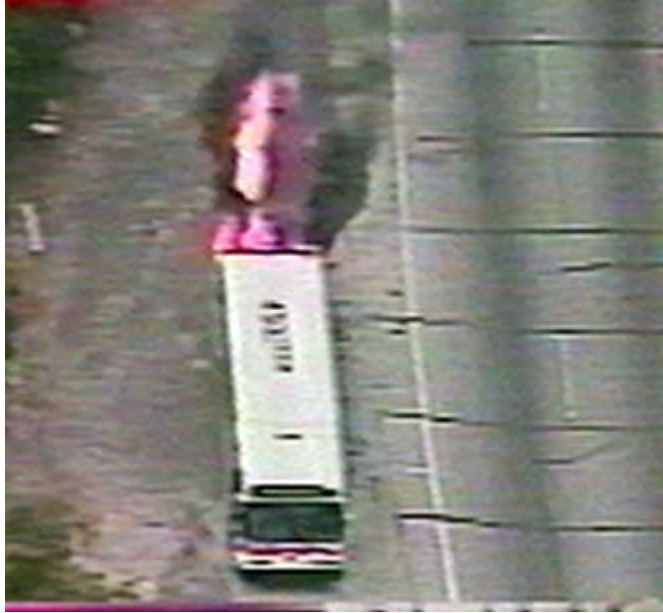
There have been several fire incidents resulting in CNG cylinder PRD actuation and subsequent cylinder depressurization. Figure 4 is an aerial overhead image of one such incident involving a transit bus. As in most such incidents, the PRD actuation resulted in the gas jet being ignited by the exposure fire (in this case an engine fire) and resulting in a jet flame.

Figure 4 Bus fire causing CNG tank PRD actuation

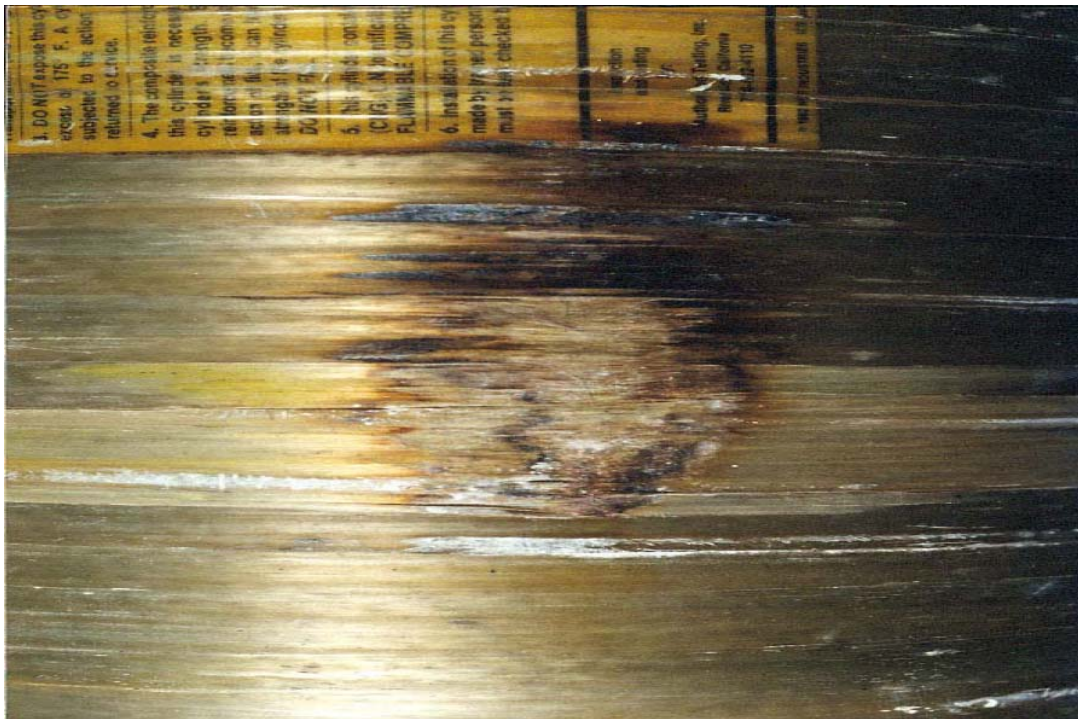
Figure 5 Composite overwrap with localized burn damage.

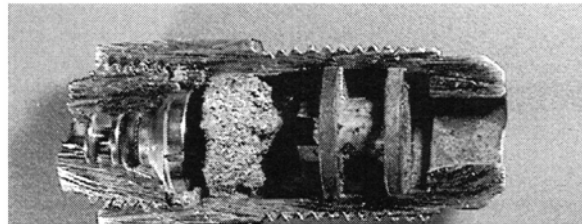
cylinders. The double PRDs on all but one of the cylinders actuated at or around their 110°C actuation temperature. The 20th tank ruptured about 15 minutes after the fire started. The ruptured tank rocketed through the depot wall, leaving the hole and charred bus shown in Figure 8. The inside of the un-actuated PRD is shown in Figure 9.

Figure 8 Un-actuated PRD on bus cylinder that ruptured (from Perrette and Wiedemann)

The cited accounts of CNG Type 3 and Type 4 cylinder failures from fire exposure in the area away from the PRD demonstrate that an additional thermal barrier is needed for these cylinders. The need for such barriers is not accounted for in the current standard bonfire tests, because the exposure flame extends over too large a length of the cylinder. It is necessary to revise or augment the current bonfire test with a more local exposure fire, such as a jet fire, that only heats a much smaller area of the cylinder.
