Explosion and Fire in Gas-Oil Fixed Roof Storage Tank (A non inherently safer design)

Yigal Riezel

Process Safety Management, consultant

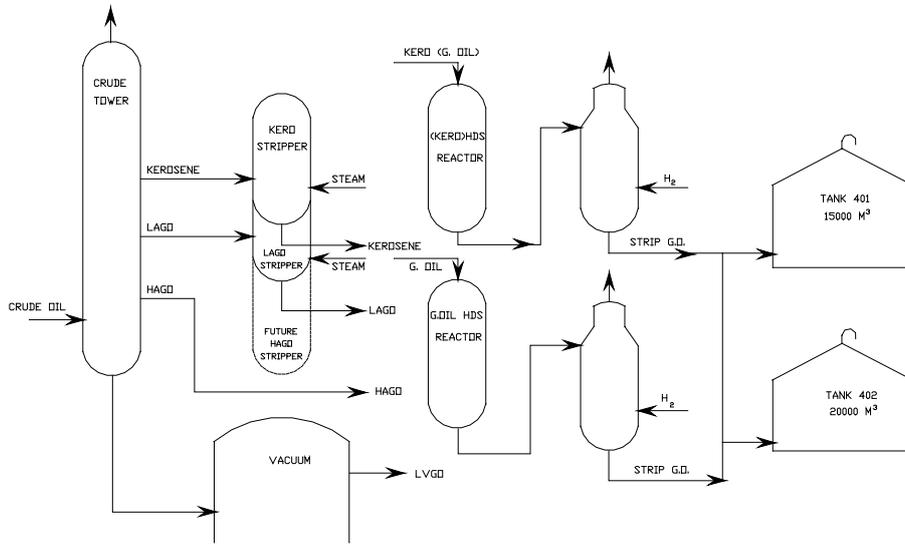
Dwg.1 – Gas Oil Flow in the Refinery

The two HDS units include a stripping section in each of them. These sections were started as Reboiling Heaters Strippers and in order to save energy adapted to steam injection stripping. As a consequence of turbidity problem in the stripped gas-oil it was decided about 20 years ago to replace the steam with hydrogen as the stripping material only in the Gas-Oil HDS unit. The hydrogen was there and cheap, the turbidity problem disappeared and there were already few examples for applying this process in some other industries. In the Kerosene HDS unit the stripping remained with steam and only after about 15 years of experience with hydrogen in the Gas-Oil HDS and when there was a higher need to operate this unit also on gas-oil the change was made and hydrogen replaced steam as stripping material in the Kerosene unit.

Hydrogen that served as stripping material and injected to the tower in a low level, replacing the steam injected before, was thought as a very light material which would dissipate upward towards the top of the tower and was not even suspected to remain as part of the bottom stream. Preceding the accident the filling of the tank was based on two parallel hydrogen stripped streams and few bypass streams with individual flash points, some of them lower than the standard 66°C Flash Point. Filling the tank to its maximum operating level left volume of 880 cu m as vapor space under the roof of tank 401.

A recommendation made by the committee after it started its investigation, to shut the hydrogen to both strippers was executed immediately. The heater reboiler stripping system replaced the hydrogen injection.

It was recommended to install the designed HAGO stripper in the Crude Oil unit in order to prevent Gas Oil blending with lower flash point. This tower is already operating few month by now.

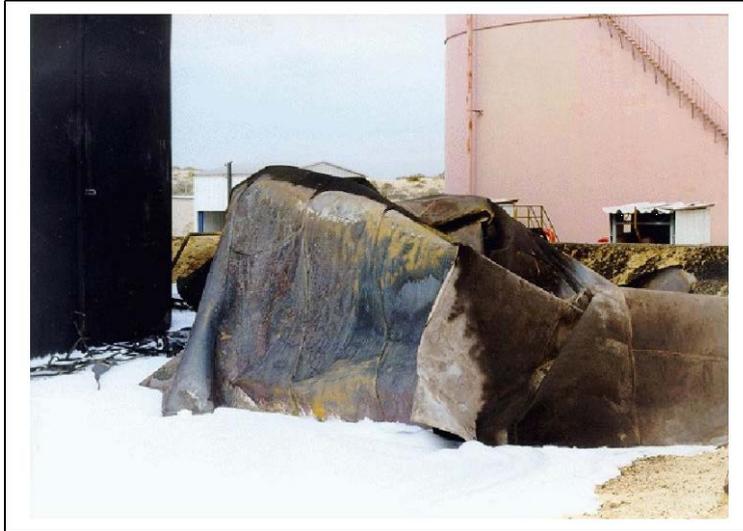
Fig. 2 – The Roof in the Dike

The first close picture identified that tank 401 exploded, its fixed cone roof ruptured and thrown into the dike. A fire was also in the dike and engulfed great part of the perimeter of the neighboring gas oil tank No. 402 with 20000 cu m capacity. At the very beginning it was difficult to identify which tank is the origin of the fire because of the very heavy smoke spread over the bound.

The immediate damage that could be identified was the loss of life of the Sample Man who was thrown with the roof in the explosion. Tank 401 lost about 3000 cu m gas-oil blown to the ground and burnt in the dike. The tank was totally damaged. The roof which had a weak seam weld connection disintegrated without tearing the walls plates. The beams inside the

Mechanical (dis)integrity. While it is better not to experience such an accident, still when it happens unfortunately, the damage should be much lower if the roof was weak seam connected to the walls. Otherwise all the capacity of the tank might spread and burn.

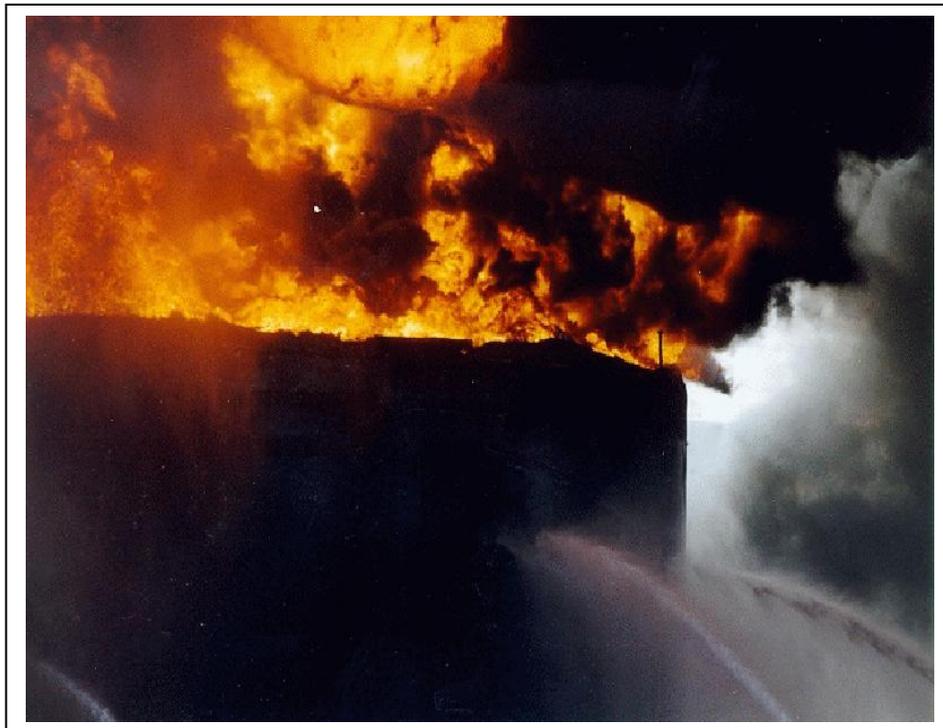
Fig. 3 - Heavy Top Phase Pool Fire

In a very short time the refinery emergency system started to operate trying mainly to cool few naphtha storage tanks that are located immediately west to the burning dike. The main fire was observed as full diameter (30 m) pool fire on top of tank 401, a ground fire in the dike between tank 401 and tank 402 and ground fire around the walls of tank 402 up to the top. Municipal fire fighting units arrived in a very short time and also other units from distances within an hour drive, were directed to arrive to the fire area. The efforts were concentrated on putting down the fire in the dike including the fire near the 402 tank. The fire on the top of tank 401 was very heavy with a heavy dense smoke which didn't enable visibility and efficient access with foam.

After about two hours of fire fighting majority of the ground fire and the 402 fire was put down leaving ground fire near 401 and mainly the fire on top of 401. It took another half an hour to fight the ground fire and than was received the decision to try to put down the top pool fire with foam. After a very concentrated effort this fire was knocked down within minutes.
