CNG and Hydrogen Vehicle Fuel Tank Failure Incidents, Testing, and Preventive Measures

Robert Zalosh

Firexplo
Wellesley, MA
bzalosh@firexplo.com

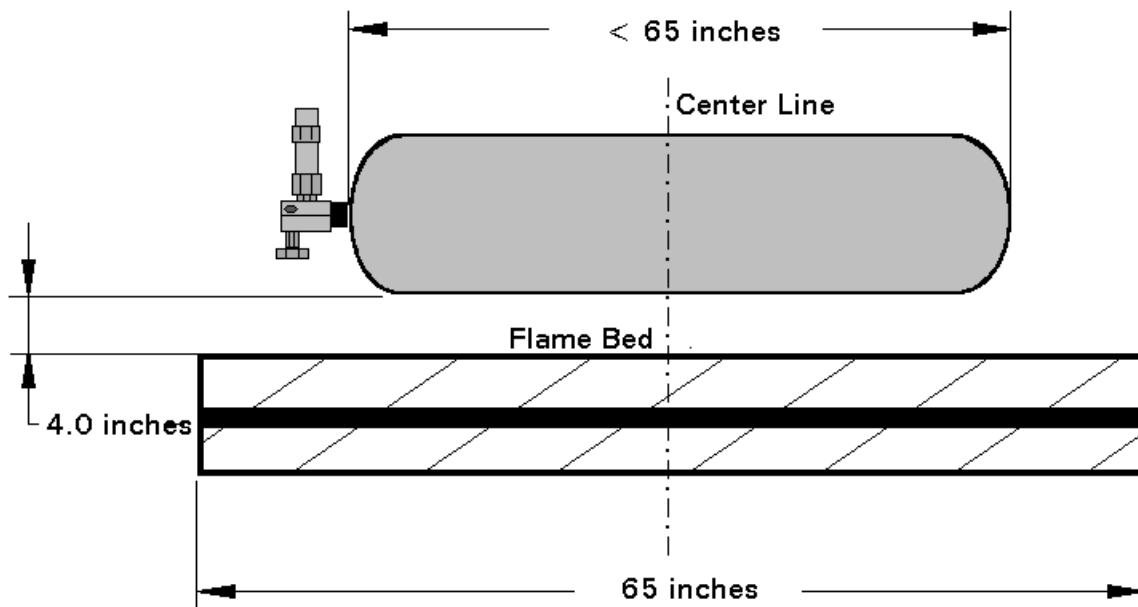
The bonfire test described in FMVSS 304 and in DOT TP304-03 (5) requires that two CNG tanks be tested, with one filled to 98% of its service pressure and the second tank filled to 24% of its service pressure. Each cylinder is positioned horizontally above a 1.65 m (65 inch) long burner or flame bed. Since most CNG cylinders are equipped with a thermally actuated Pressure Relief Device (PRD) next to the cylinder valve, the test has specific requirements for the cylinder and PRD location above the burner, as shown in Figures 1a and 1b. Cylinders shorter than 1.65 m are situated over the centerline of the burner, but cylinders longer than 1.65 m are situated such that the PRD(s) and valve are not directly exposed to the burner flame. The PRD on the short cylinder shown in Figure 1a is required to be shielded from the burner flame by surrounding it with a box made of steel plate (5). If the cylinder is

Figure 1a FMVSS 304 Bonfire Test for CNG cylinder shorter than 65 inches. From (5)

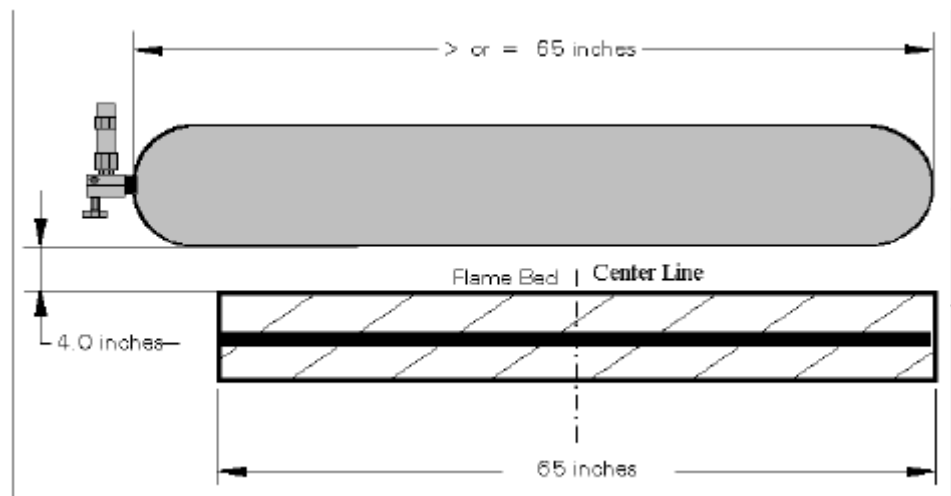
protected with thermal insulation instead of a PRD, it is positioned symmetrically with its center directly above the center of the burner.

Figure 1b FMVSS 304 Bonfire test for CNG cylinder longer than 65 inches. From (5)

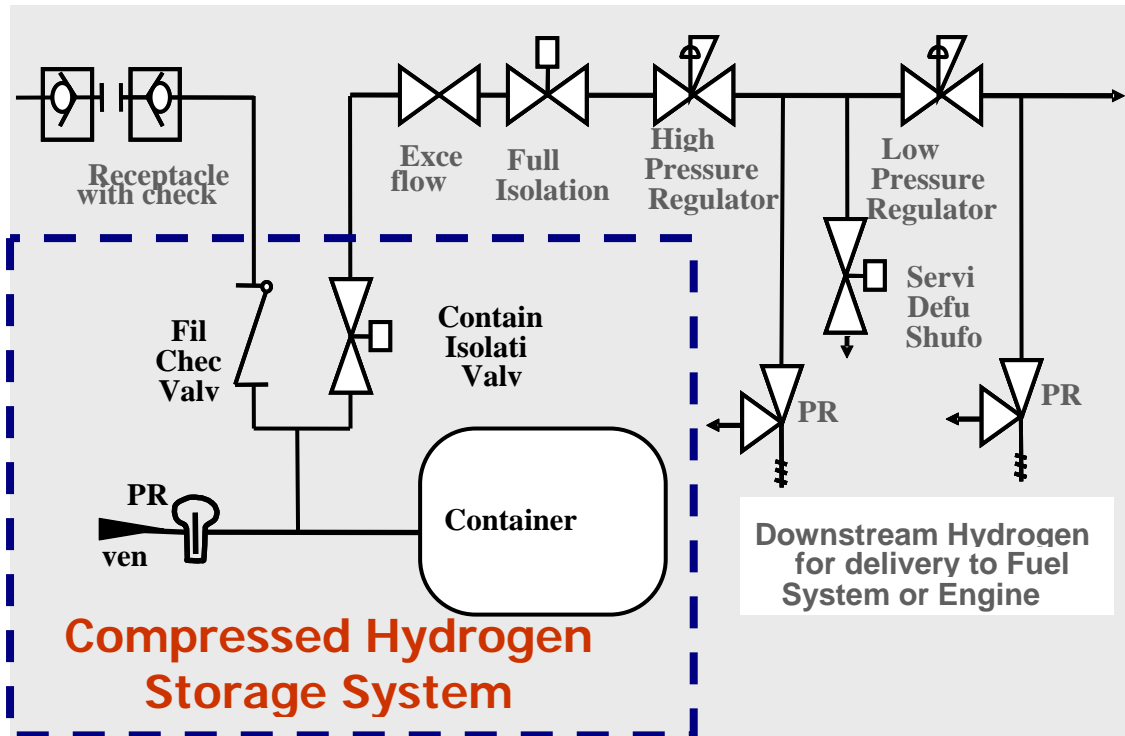
Figure 2 is a schematic diagram of the fuel system addressed in SAE J2579. The dashed line designates the boundary of the hydrogen storage system, which includes the PRD, the container isolation valve and the fill check valve. The standard includes requirements for minimum hydrogen leakage in crash tests analogous to those in FMVSS 303 for CNG and FMVSS 301 for gasoline fuel systems. There is also a currently ill defined vehicle level fire exposure test. According to the chair of the SAE committee responsible for SAE J2579, since the details of the test requirements and methods of verification are currently undergoing verification testing, the document will be issued as a SAE Technical Information Report rather than a standard.

Figure 2 Hydrogen Fuel System in SAE J2579

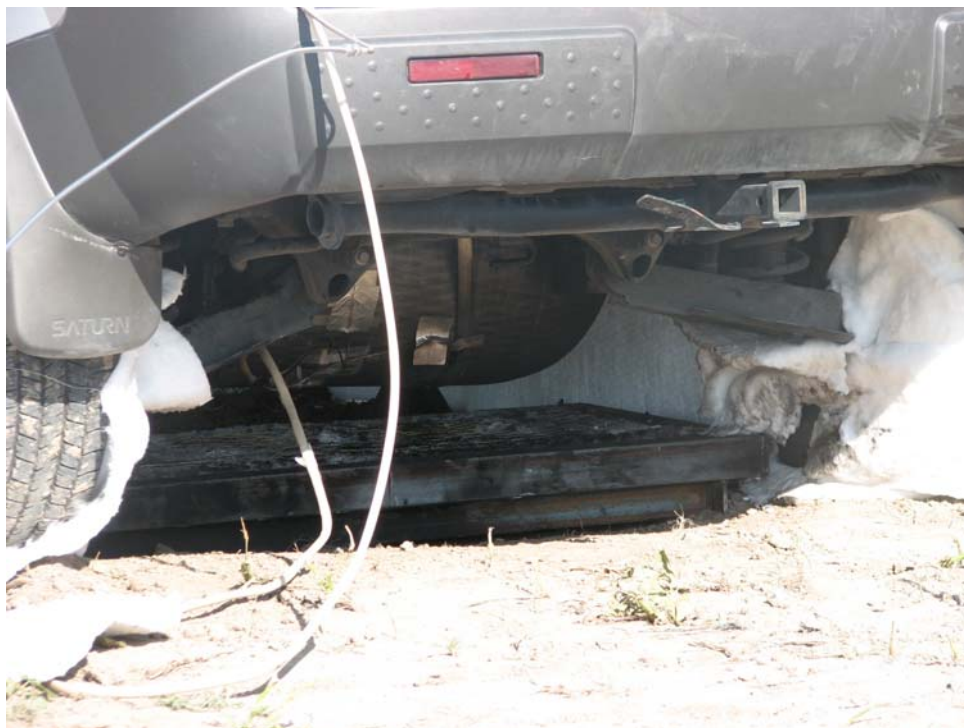
Both tests were conducted with propane burner fires under cylinders filled with hydrogen at a pressure of 32 to 34 MPa (4600 to 4900 psi) without PRDs. One test was conducted with a 72 liter Type 4 cylinder by itself, while the second test was conducted with an 88 liter Type 3 cylinder installed under a Sports Utility Van as shown in Figure 10. The Type 4 cylinder ruptured after 6 minutes 27 seconds of fire exposure. The burner flame ignited the SUV (see Figure 11) before the Type 3 cylinder ruptured after 12 minutes 18 seconds of fire exposure. In both cases, the cylinder wraps prevented the hydrogen temperature and pressure from increasing significantly above their pre-test values.

Figure 10 Burner below Type 4 cylinder under a SUV (from Zalosh)
