The Strange History of Tank Inerting

Jack Devanney

1 The Origins of Tankship Inerting

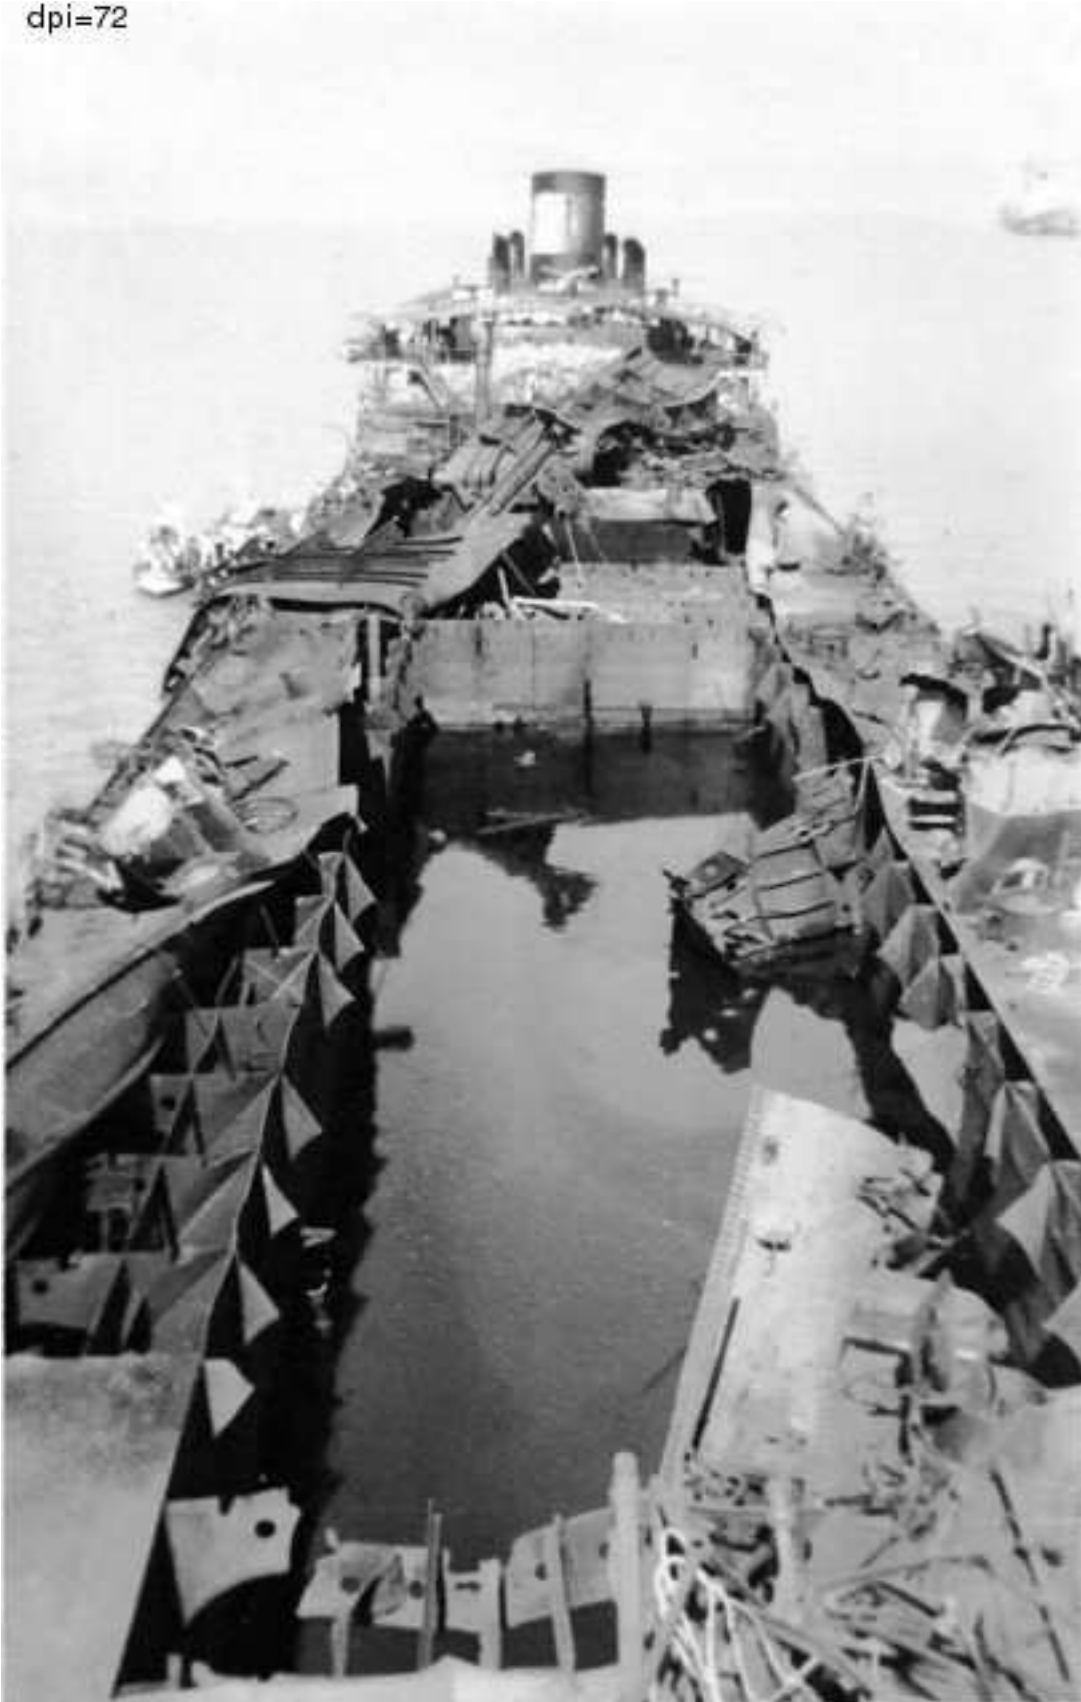
Figure 1: Stanvac Japan after tank cleaning explosion. 19 killed. Source: Ships Nostalgia

One of the most dramatic of these casualties was the STANVAC JAPAN, Figure 1. She was almost certainly tank cleaning when she exploded in the Arabian Sea in October, 1958. The explosion ripped the deck off almost all the center tanks and tossed the midships house into the sea. At least 19 were killed, including everybody on the bridge. Stanvac was a joint venture between Esso and Mobil. CTX has no evidence that either reacted to the casualty in any meaningful way.

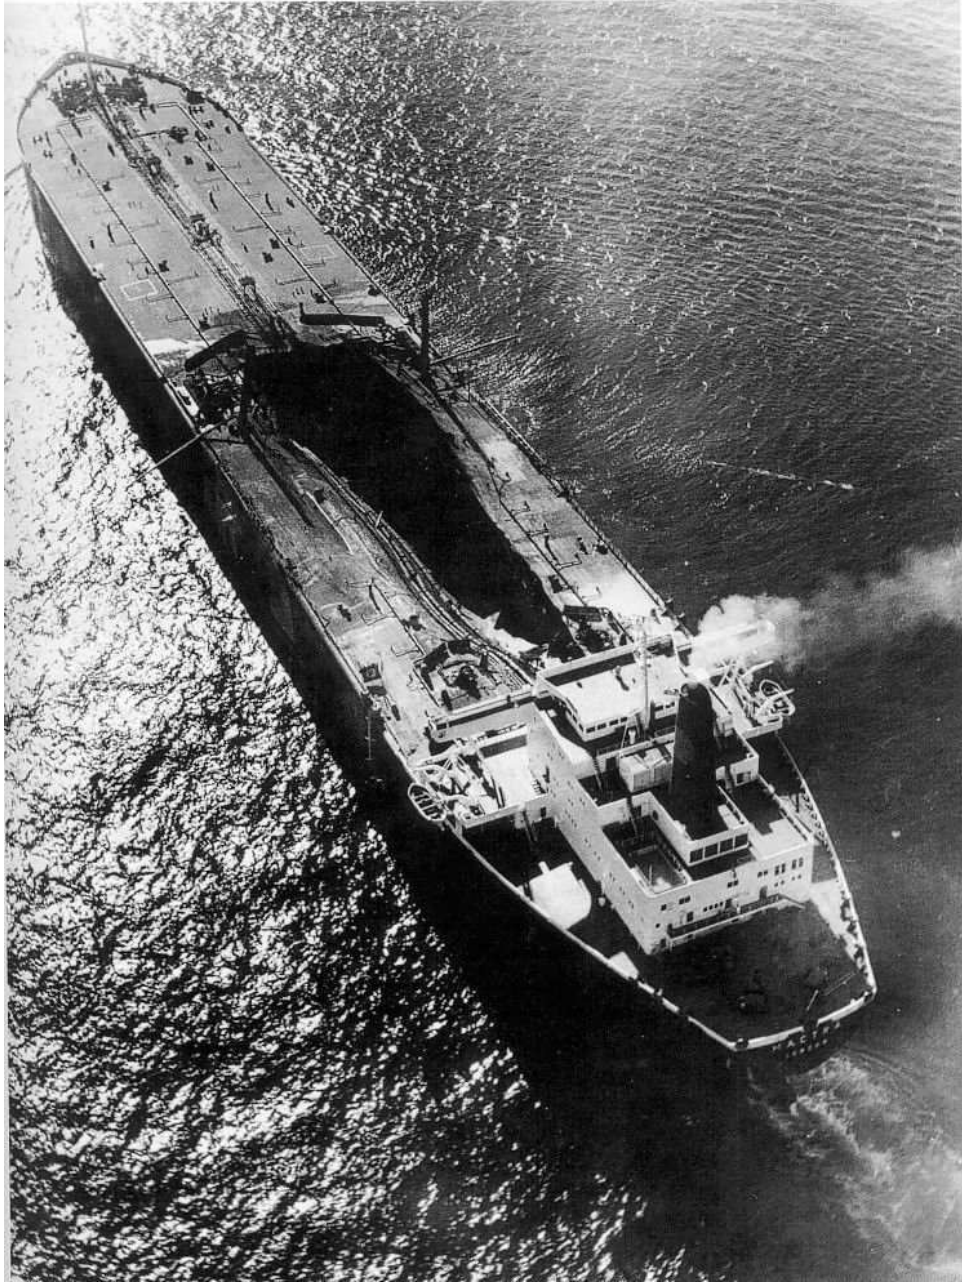
Figure 2: Mactra deck after tank cleaning explosion. Two killed.
Source: Auke Visser, supertankers.topcities.com

Cargo tank cleaning is accomplished by machines that look like and work like enormous lawn sprinklers. These gadgets shoot a revolving high pressure jet of sea water around the tank, in theory blasting the surfaces clean of oil. Two of the tankers involved, the MARPESSA and the MACTRA were Shell ships. The third was the brand new KONG HAAKON VII. The MARPESSA, on her maiden ballast leg, sank killing two crewmen. The MACTRA, Figure 2, and the KONG HAAKON VII, Figure 3, had a large portion of their main decks blown away but survived.

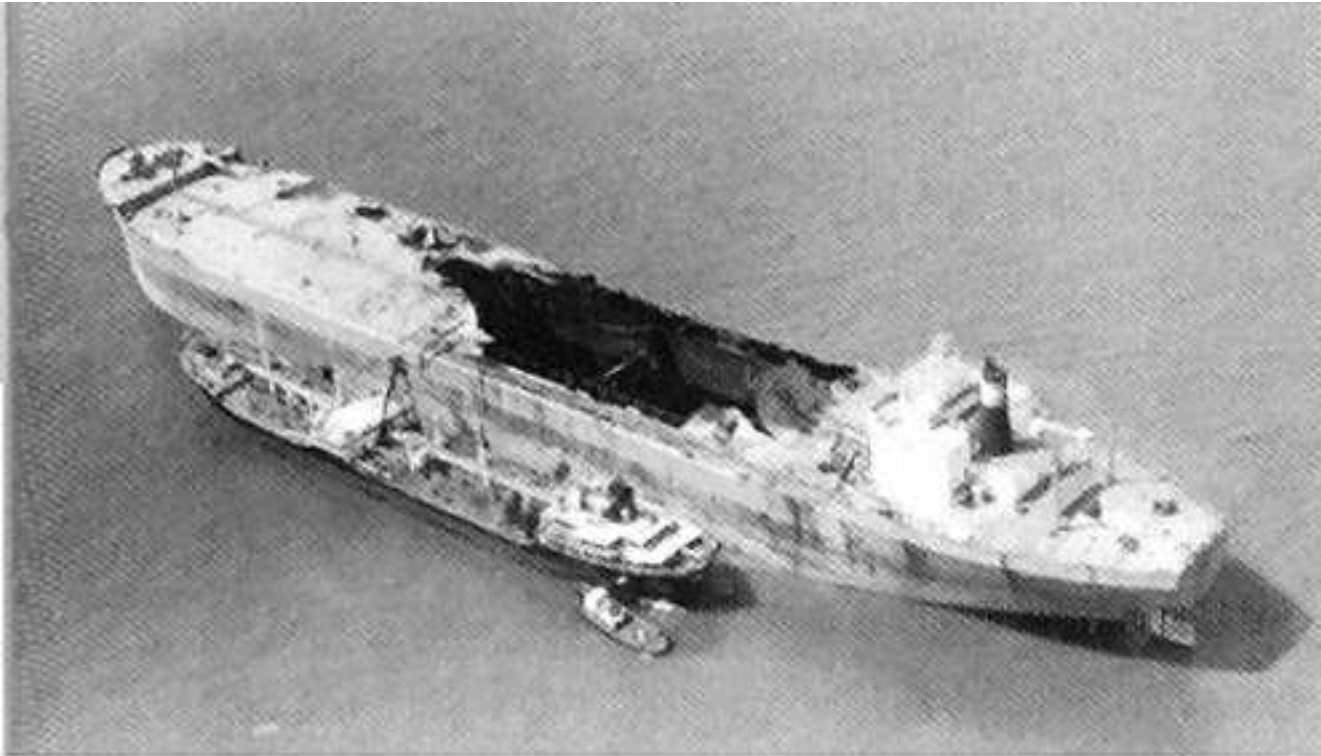
Figure 3: Kong Haakon deck after tank cleaning explosion. Obvious similarity to Mactra. Source: Auke Visser, supertankers.topcities.com
