HYDROGEN CYLINDERS AND TRANSPORT VESSELS

IGC Doc 100/03/E

EUROPEAN INDUSTRIAL GASES ASSOCIATION

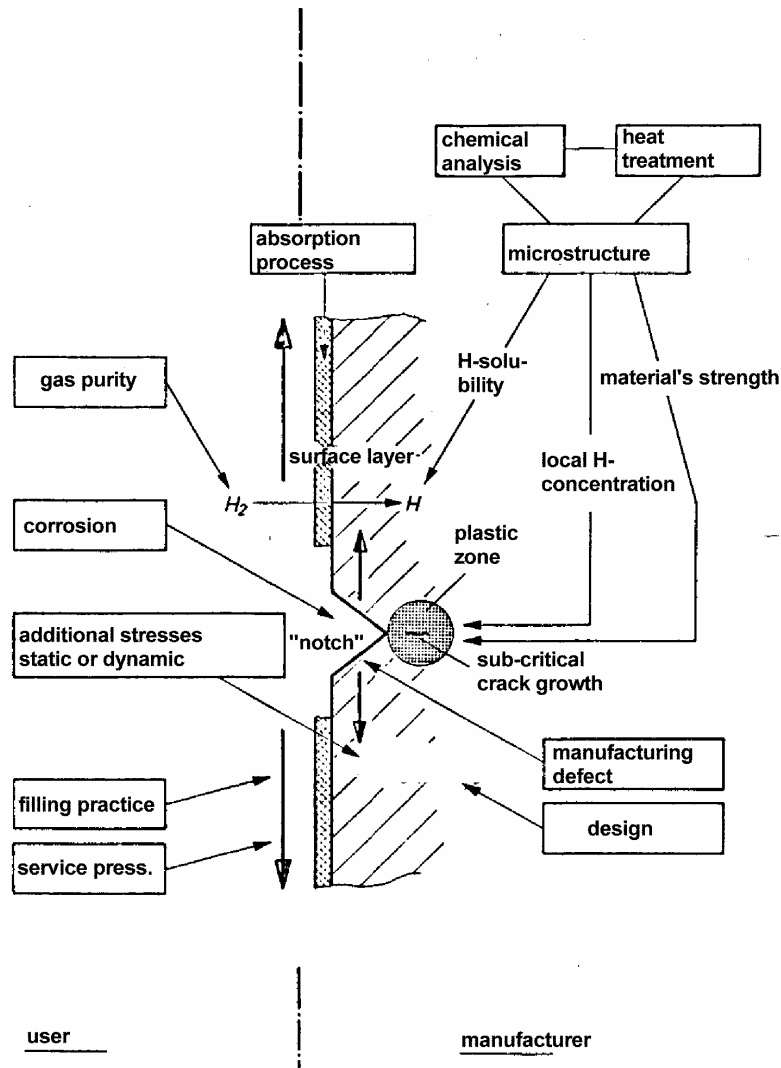
Figure 1: Hydrogen induced cracking (factors of influence)

The material and design aspects, which the cylinder manufacturer has to consider, are shown schematically on the right hand side of the figure. The basic requirements are:

- a steel of limited tensile strength with a suitable micro-structure and freedom from harmful inclusions
- a cylinder which is free from harmful surface defects

The main factors that influence hydrogen embrittlement of a pressure vessel are shown in figure 1.

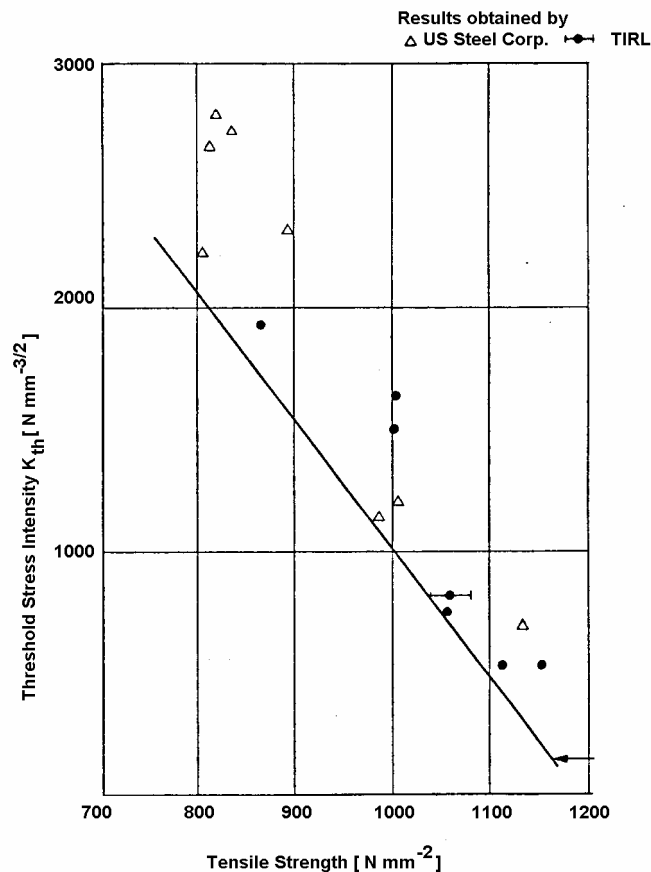
Failure of the cylinder or vessel/tube is imminent when the growing crack attains the conditions for crack growth to proceed under static load. This is controlled by the static threshold stress intensity K_{th} , which is a material property in the presence of hydrogen, but depends on the tensile strength and the microstructure of the steel. In figure 2, the results obtained by Loginow [8] are compared with findings from TI Chesterfield using cylinder material.

Figure 2: Threshold stress intensity for sustained load crack growth of CrMo steel in hydrogen of 200 bar

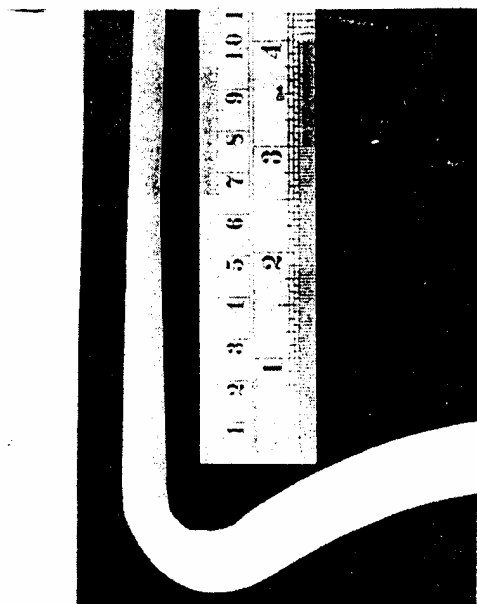
Another contributory factor to the failure mechanism was a poor base design. An example is shown in figure 3.

Figure 3: Base profile of a failed hydrogen cylinder

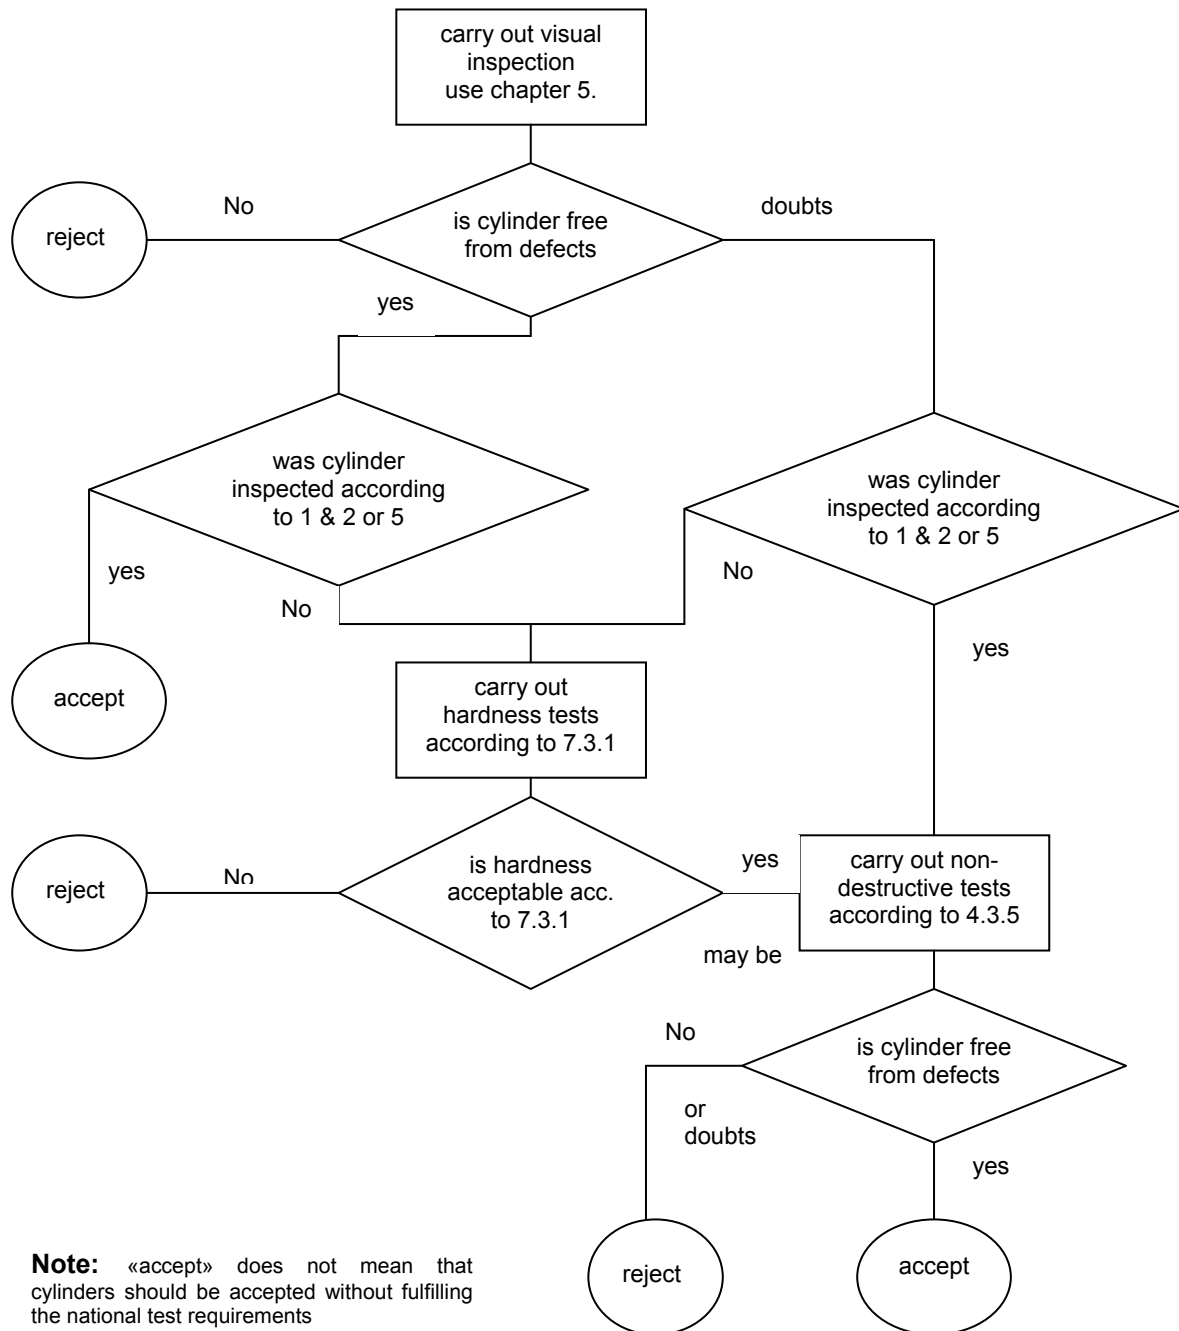
The recommended procedure is explained in a flow chart, figure 4.

Note: «accept» does not mean that cylinders should be accepted without fulfilling the national test requirements

«reject» means reject from hydrogen service

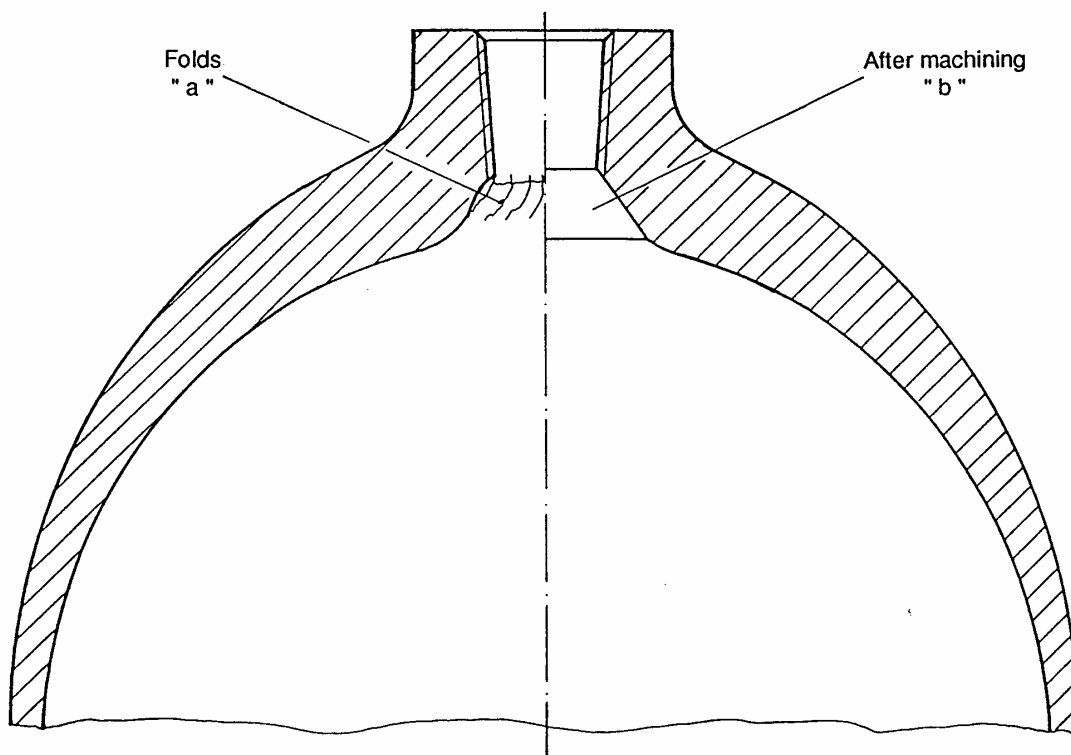
After machining, the whole area shall be re-inspected and measured for thickness. If the defects have not been completely removed, or, if the thickness at any part of the machined area is less than twice the minimum wall thickness shown on the drawing, the cylinder shall be deemed not to comply with the requirements of this document.

Figure C/1: Cylinder neck folds before and after machining

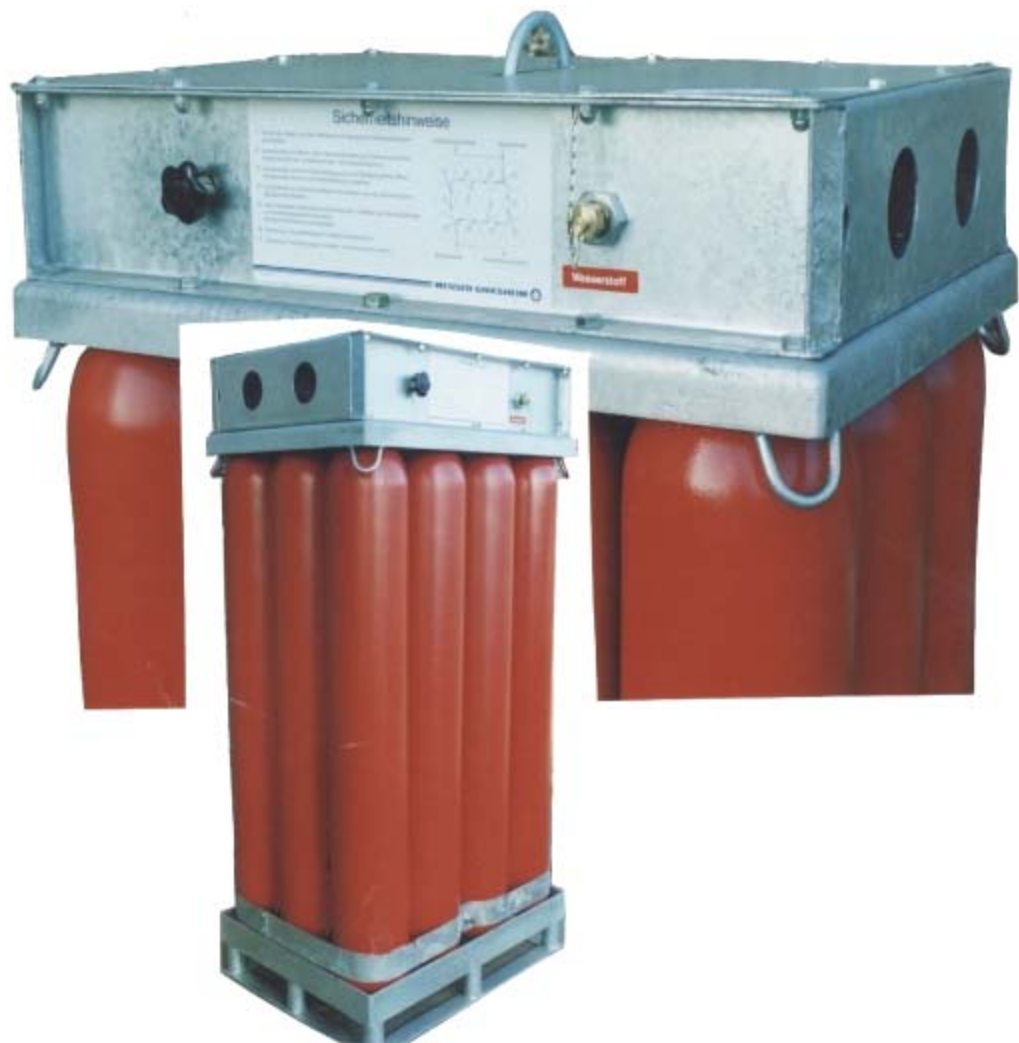
One example of hydrogen cylinders mounted in a bundle (see EN 13769) to avoid local unfavourable stress concentration and external corrosion, is shown in figure D.1 and D.2

Lifting points are provided near the top of the bundle. The structure is of sufficient stiffness so that excessive stresses are not induced in the cylinder wall by deflection during lifting or transportation.

The outer cylinder surface has to be adequately protected against corrosion.

Figure D.1 : Modern hydrogen bundle design, according to EN 13769, containing 12 cylinders with 50 ltr. watercapacity/ 200 bar filling pressure each

An example of good engineering practice to avoid local unfavourable stress concentration and external corrosion is shown in appendix D.

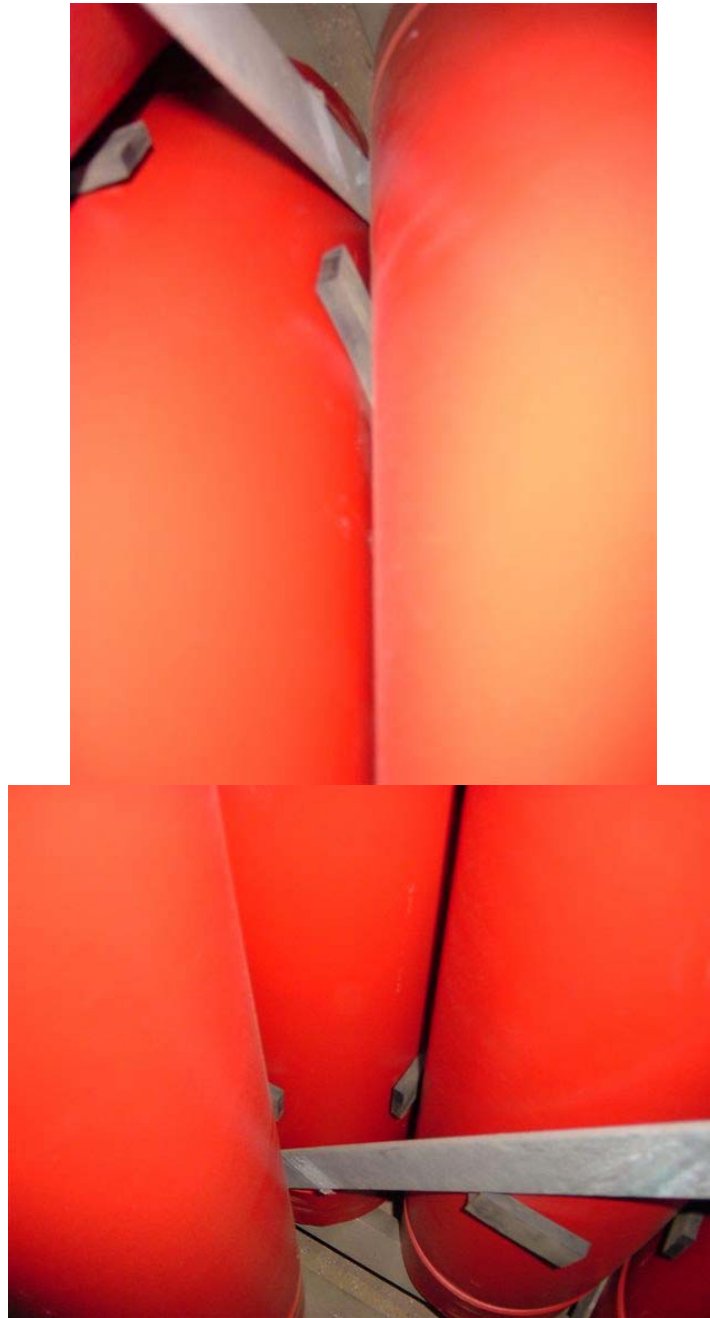
Figure D.2

Bundle design example

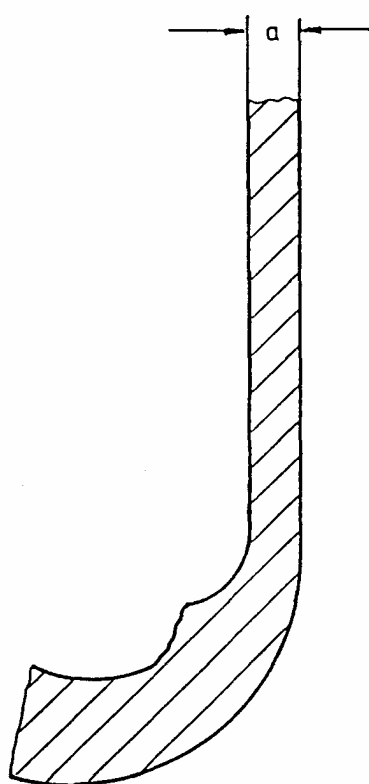
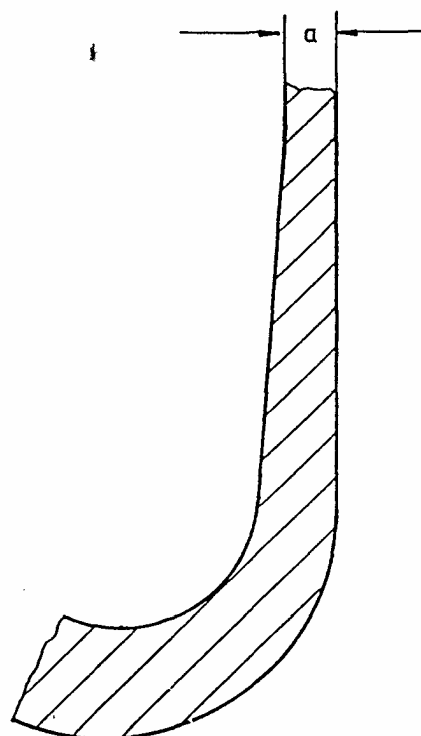
The thickness of a cylinder wall shall increase progressively in the transition region, from the cylindrical part to the base, without abrupt changes of profile.

**BAD PROFILE**

**GOOD PROFILE**

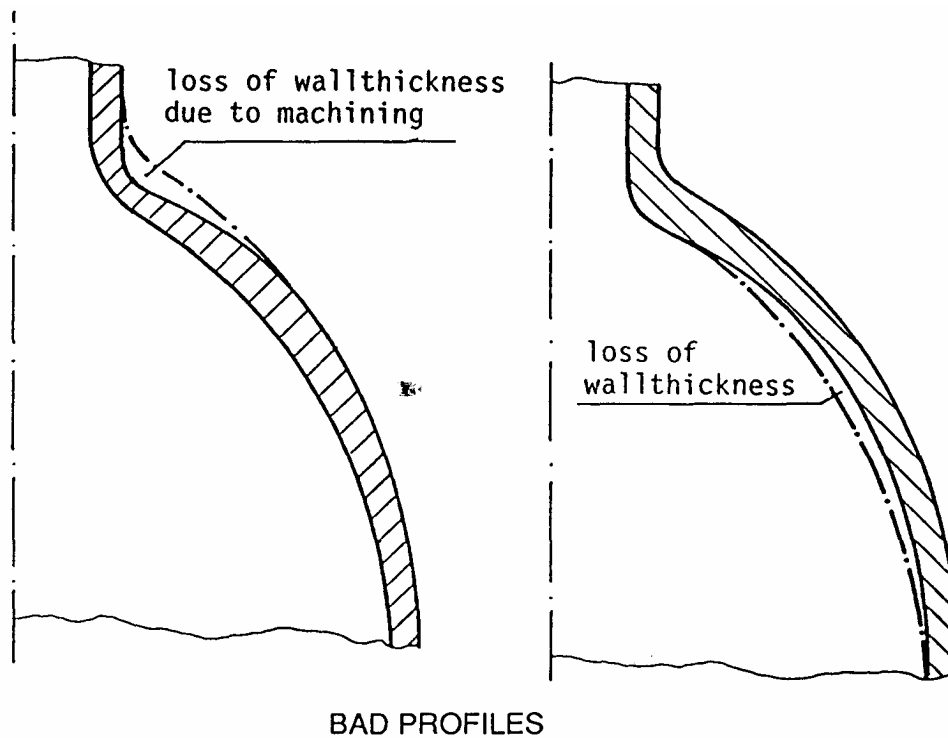
The wall thickness of the neck shall increase progressively from the cylindrical part to the opening. Care should be taken if parts of the neck have been machined.

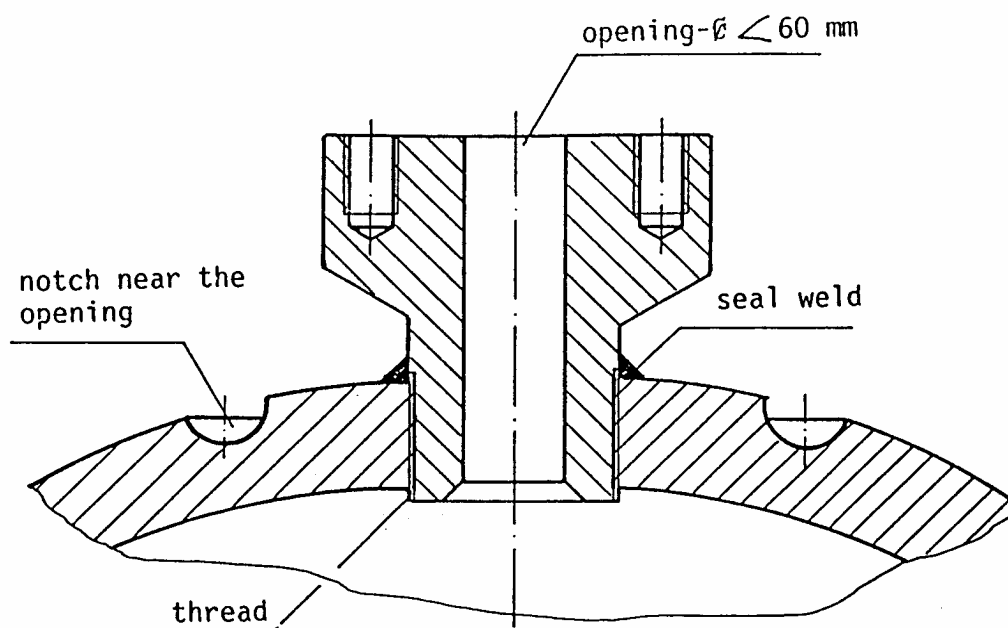
- small diameters of the opening do not allow a sufficient visual inspection of the inner surface
- seal welds on a high strength steel may crack and should not be used
- notches on the outer surface near the opening can act as stress raisers
- threads which are in contact with hydrogen can act as stress raisers and should be avoided
- material used for plugs or end closures shall be selected from high quality steel and shall be free from significant internal defects
- gasket material should be hydrogen compatible

Example with unsatisfactory experience

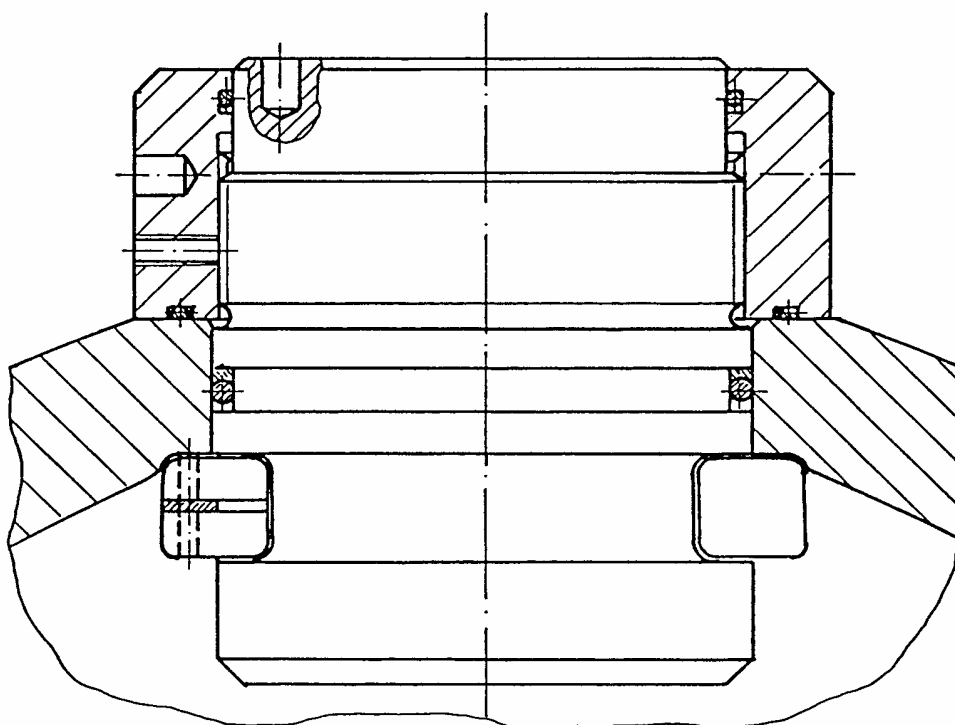
Example 1 *

Example with satisfactory experience

* Rapid-Closing connection for seamless pressure vessels of Mannesmann Stahlflaschen AG, Düsseldorf

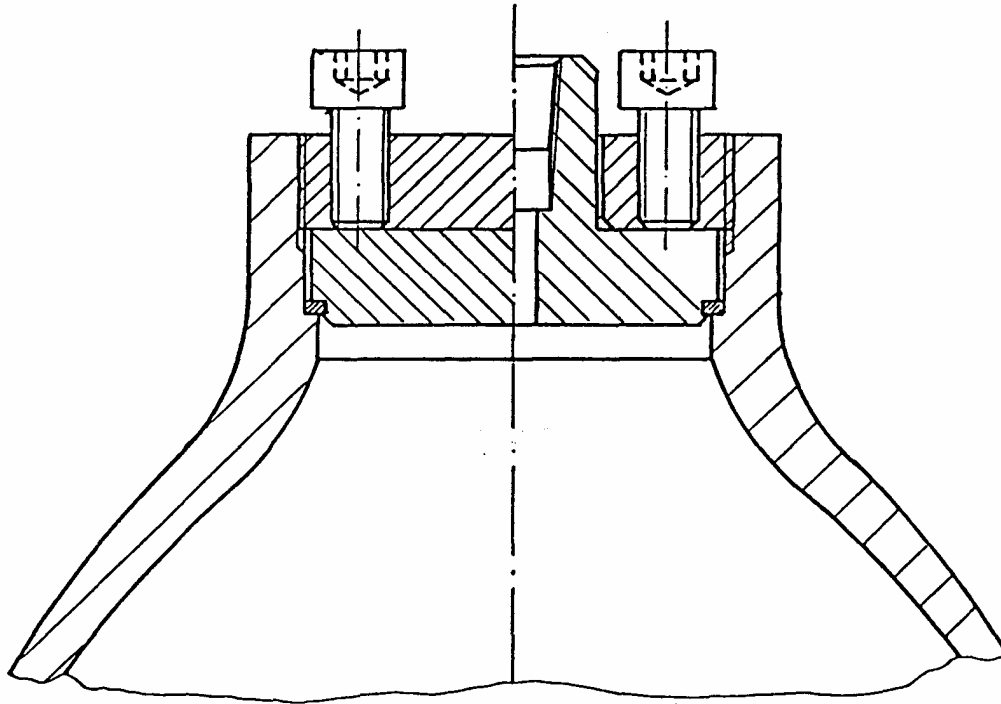
Example 2 **

Example with satisfactory experience

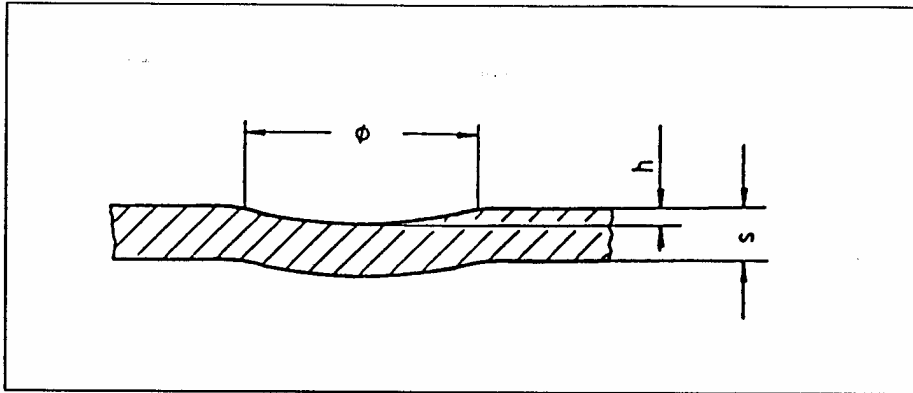
Figure F/1: Dent

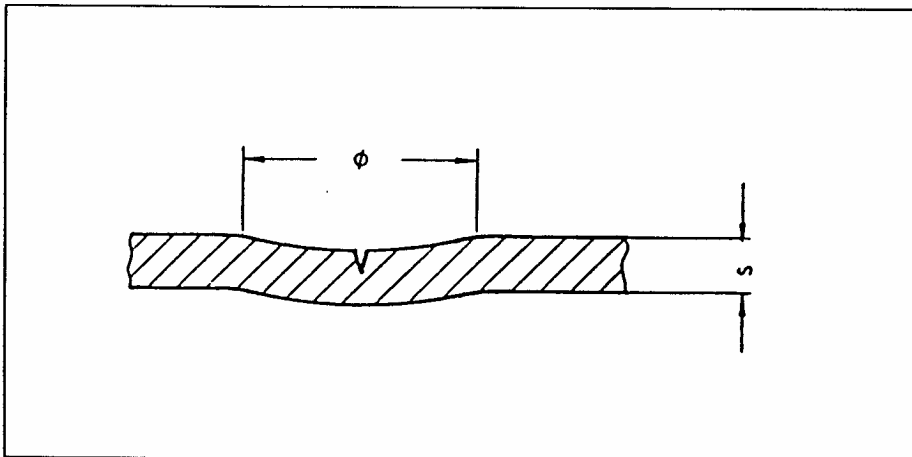
Figure F/2: Dent containing cut or gouge

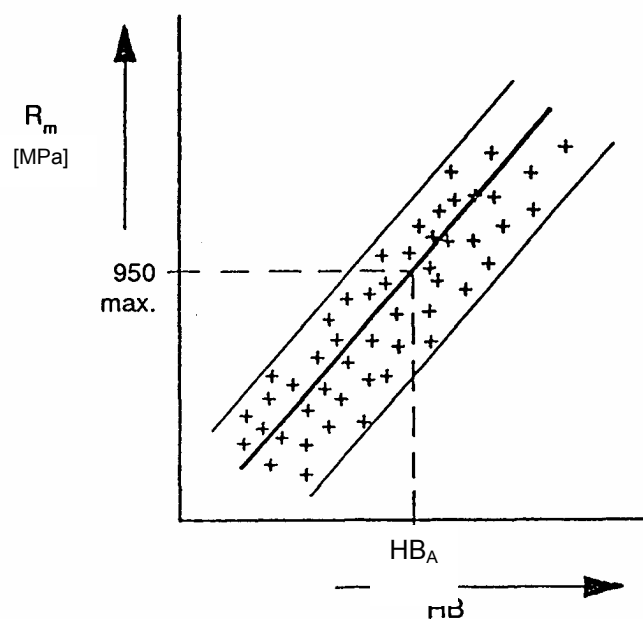
After having established the scatter band, the most representative correlation between hardness and tensile figures for a certain cylinder design, material and manufacturer shall be used for conversion, for example see figure G/1 [13] where \bar{H}_B is the average value of the hardness measured.

Figure G/1: Diagram for HB/Rm-Conversion

This correlation has to be determined, preferably by the cylinder manufacturer, using test pieces taken from manufactured cylinders.

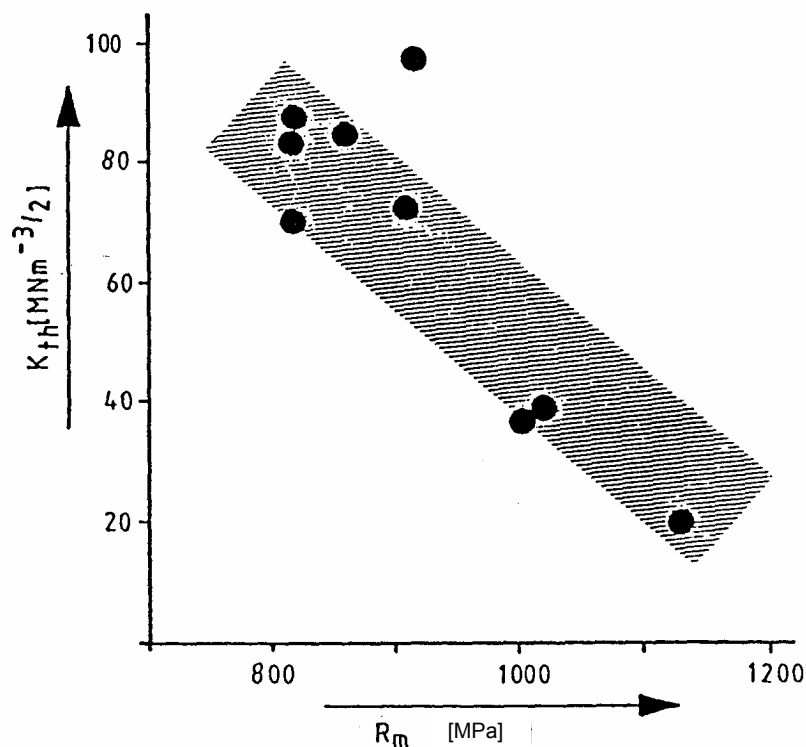
Figure H/1: Comparison of CrMo threshold stress intensity data

As an example figure H/1 shows the results of fracture mechanics experiments [8] which demonstrate how the threshold stress intensity for sustained crack growth in hydrogen decreases with increasing tensile strength of the steel.
